## Chebeague Island Eelgrass Survey

October 15, 2014

Re: Eelgrass Survey, Chebeague Island, Maine  
Normandeau Project Number: 23529.000

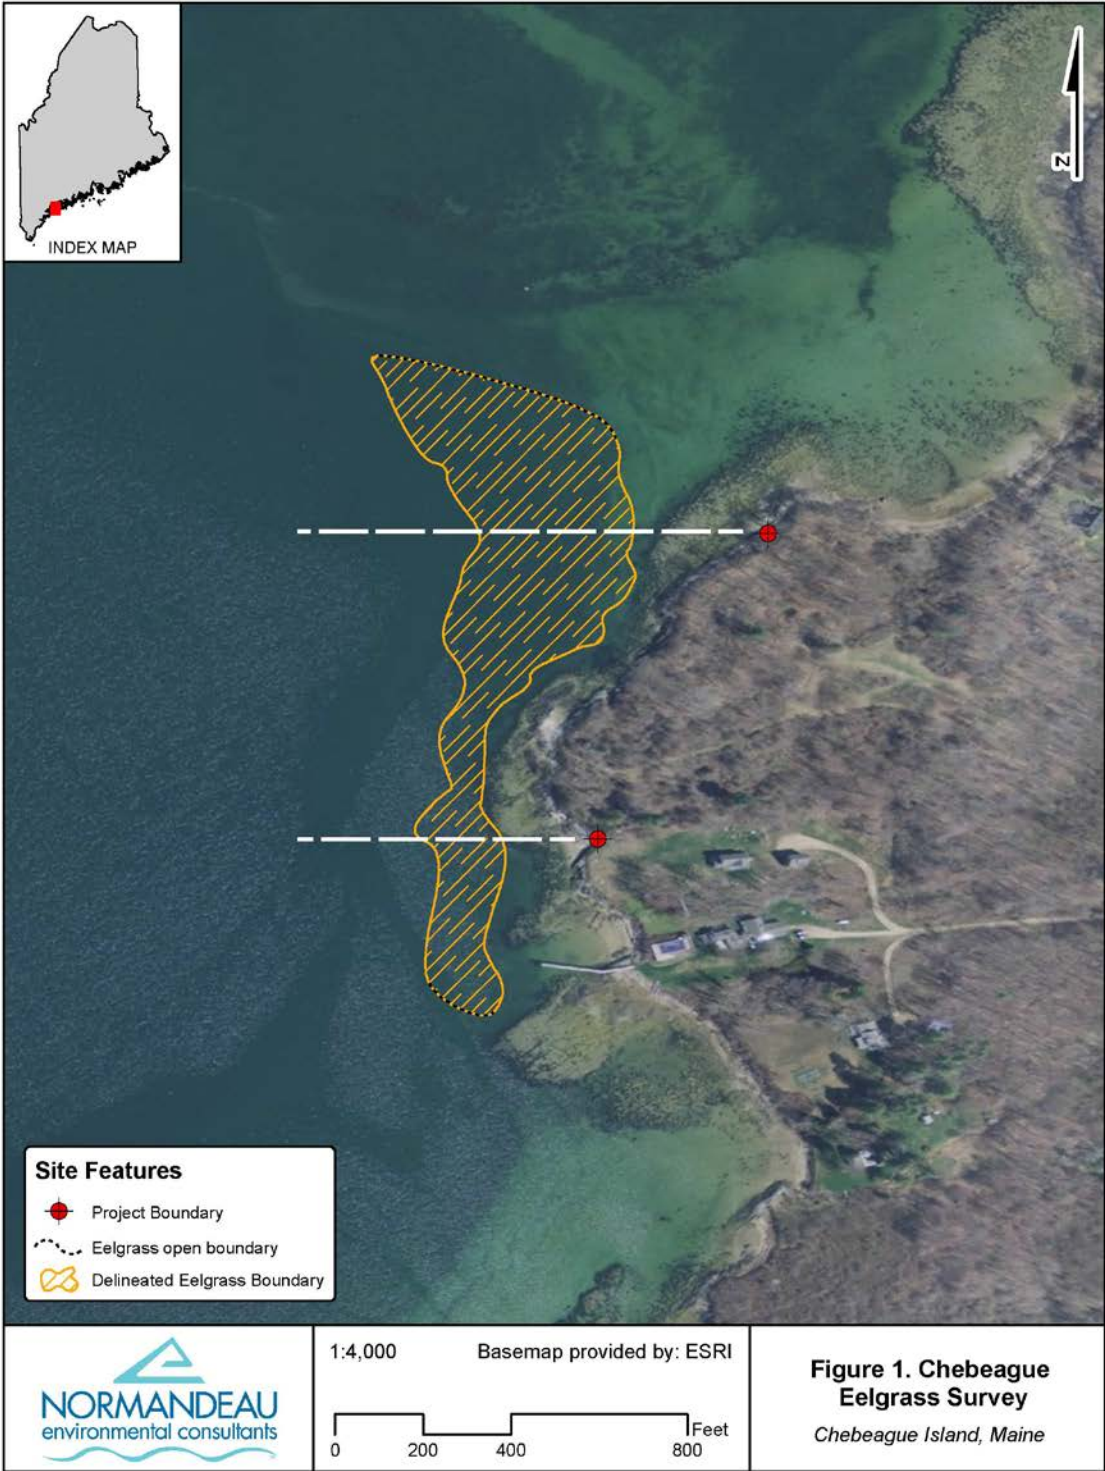
The camera was towed across the project area in a zigzag pattern to catch the inner (shallow) and outer (deep) boundaries of the eelgrass beds, as well as any patches or bare spots within the beds. Multiple passes were made to obtain reasonable coverage of the project area and GPS coordinates were recorded at each boundary point. Boundaries were based on percent cover as described in the Tier I Guidance [e.g. sparse (1-10% cover), low (11-25% cover), moderate (26-50% cover), and high (>50% cover)] and were located where coverage was at least 1-10%. Eelgrass bed boundaries are shown in Figure 1.

Eelgrass was observed within, and beyond, the project limits (Figure 1) from the low intertidal into the subtidal zone to depths greater than 20 feet. Densities of eelgrass within beds were generally moderate (26-50% cover) to high (>50% cover) and the boundaries of the beds were generally distinct with few exceptions. The exceptions included scattered patches of sparse densities within the nearly continuous bed, and areas that were greater than 26 feet deep. Eelgrass was observed growing in the cobble and boulder areas in the shallow subtidal as well as on the sandy and gravelly substrate that was prevalent in most areas.
