# SITE EVALUATION - PHASE 2

## Sunset Landing Project

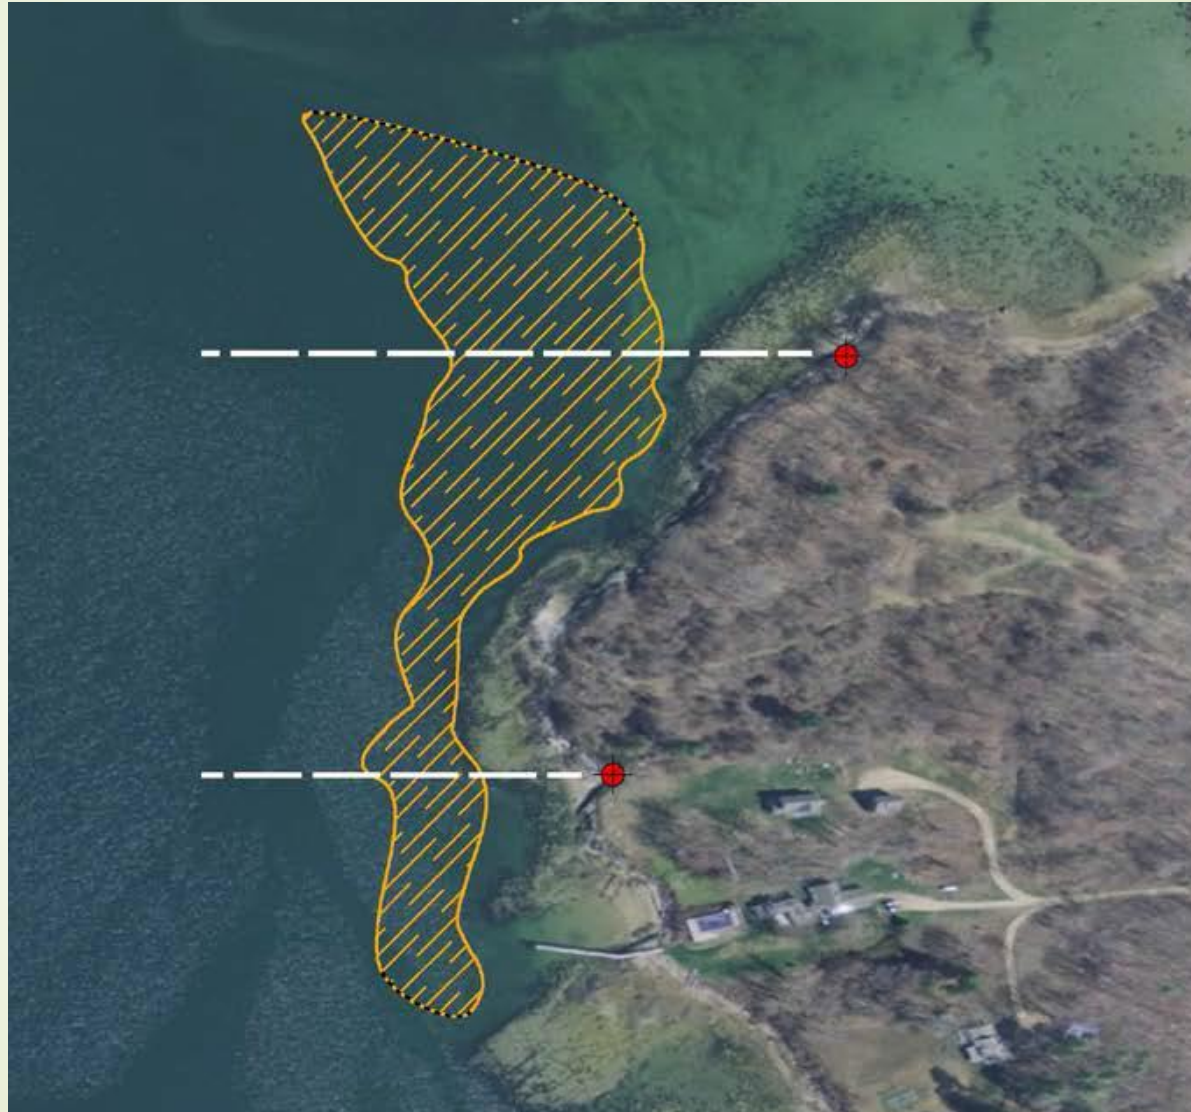
# Eel Grass Survey

- **Maine DEP and US Army Corps of Engineers requires Avoidance and Minimization of Eel Grass Bed Impacts**
- **Impacts greater than 500 SF generally require Compensation**
- **Consultation with Maine DEP and US Army Corps of Engineers required for any direct impacts or secondary impacts**

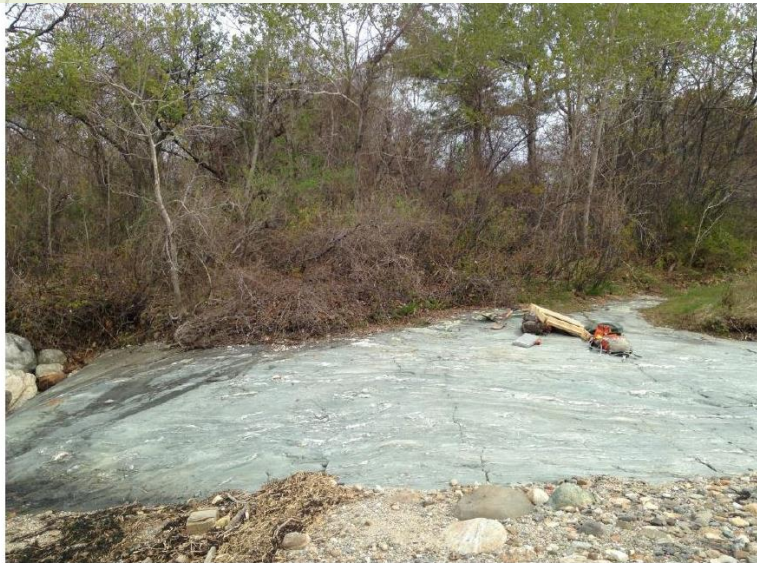
**Photo 9.** East view of the historic shell midden identified during the 2015 survey. The outlet of the unpaved access road across the parcel is visible in the right distance of the photo.

- One Shell Midden found - historic period origin
- Attributed to mid-twentieth century foot traffic
- No further investigation recommended

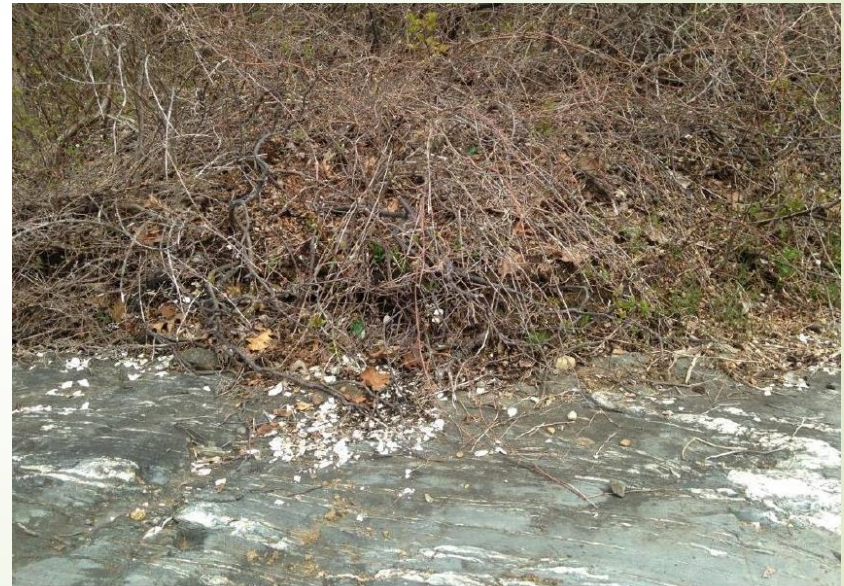
**Photo 10.** East view of historic shell midden identified during the 2015 survey.

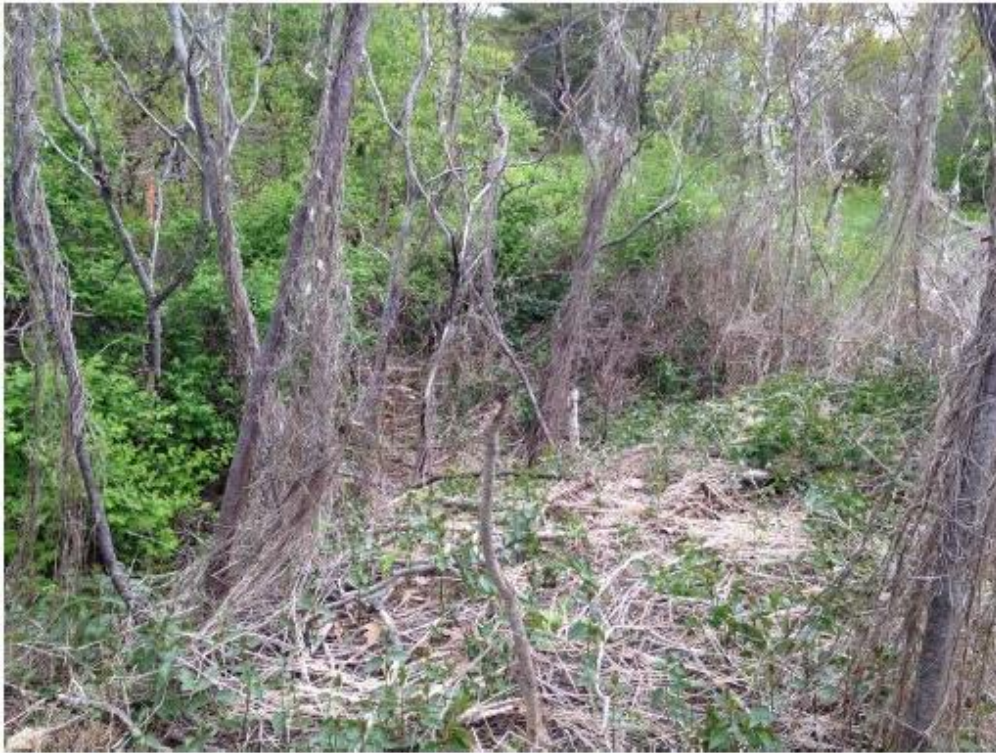
Photo 13. North view of CH-1 (ME 110-006), the photographer is positioned adjacent to the eastern side of the cellar hole depression.

- The Phase 1 survey identified 3 cellar holes
- Cellar Hole 1 MHPC site ME 110-006
- Located in the center of the property
- 314 Artifacts recovered

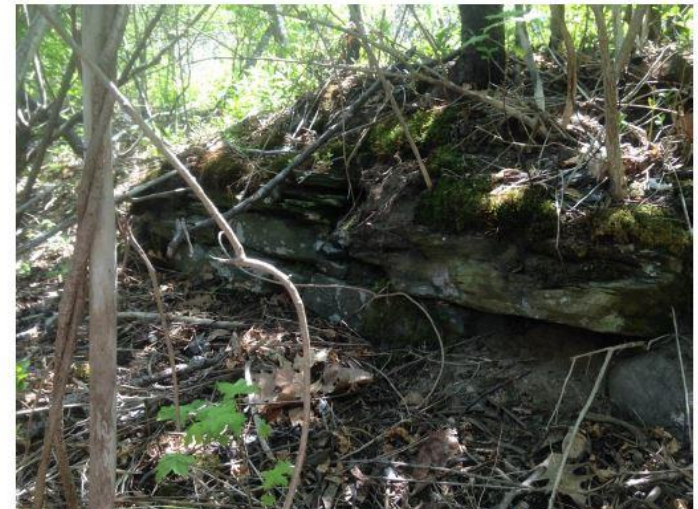
Photo 15. View of CH-1 (ME 110-006) south wall from within the cellar hole depression.

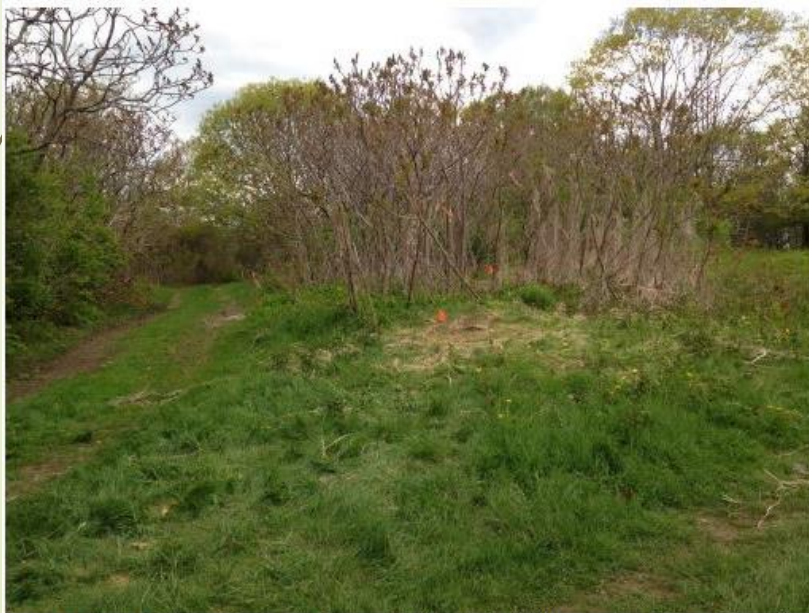
**Photo 16.** East view of the CH-2 depression located within a patch of lily of the valley and adjacent to CH-1 (ME 110-006)

- A series of surficial stones in square formation
- Located 2m east of CH-1 – likely an outbuilding
- 141 Artifacts recovered

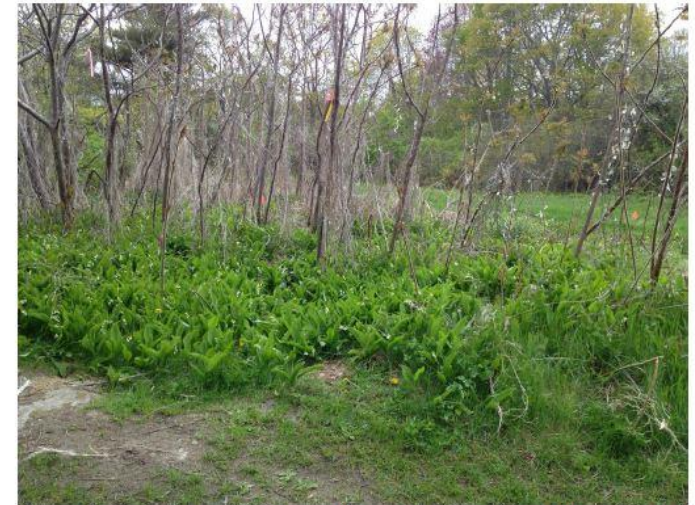
**Photo 17.** North view of CH-2; note the patch of lily of the valley within and surrounding the cellar hole.

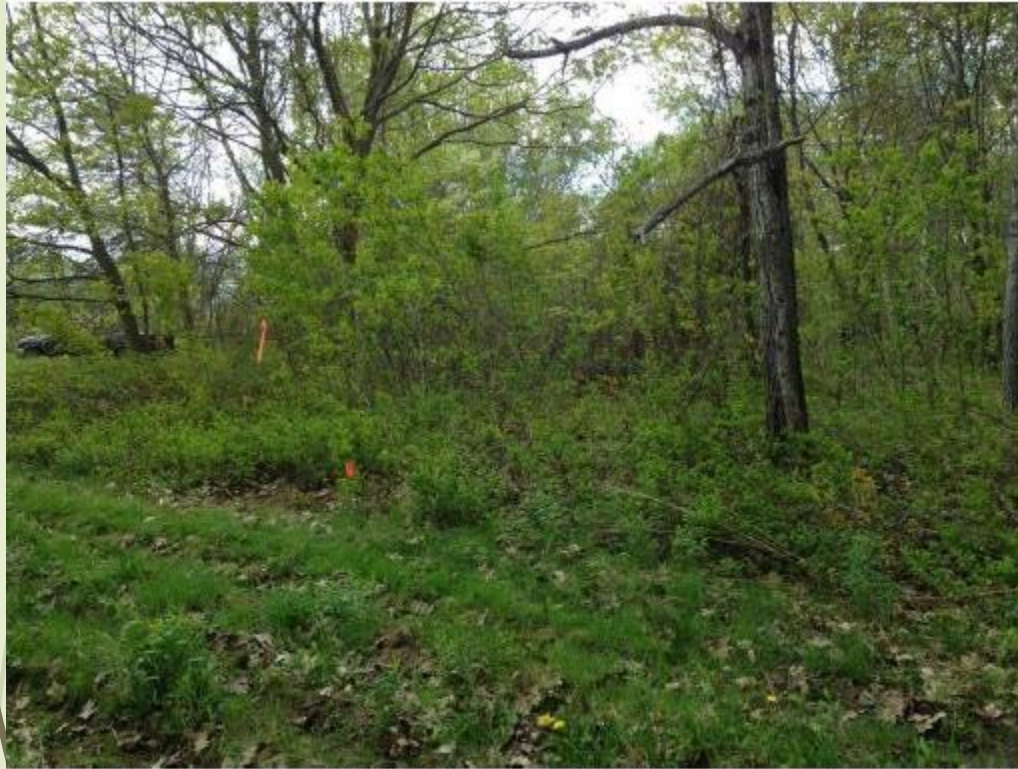
Photo 18. Northeast view of CH-3, the orange pin flag in the center foreground marks CH-3 S5. The photographer is positioned on a section of the former access road.

- Located 50m southeast of CH-1
- Slight depression (5m dia) and series of intermittent stones in square pattern
- Two boulders may have marked access road
- 96 artifacts recovered

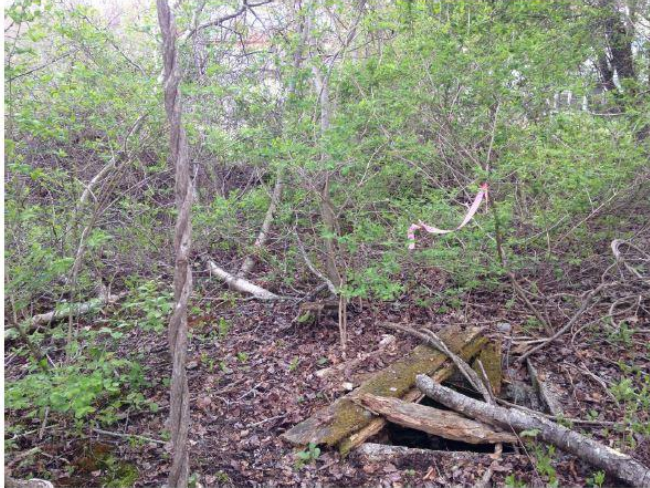
Photo 20. Northwest view of the hand dug well located along the southern property boundary.
